GREENVILLE DAM # 3

(NDI Number PA 01081 Penn DER 43-1)

GREENVILLE MUNICIPAL AUTHORITY.

PHASE I INSPECTION REPORT

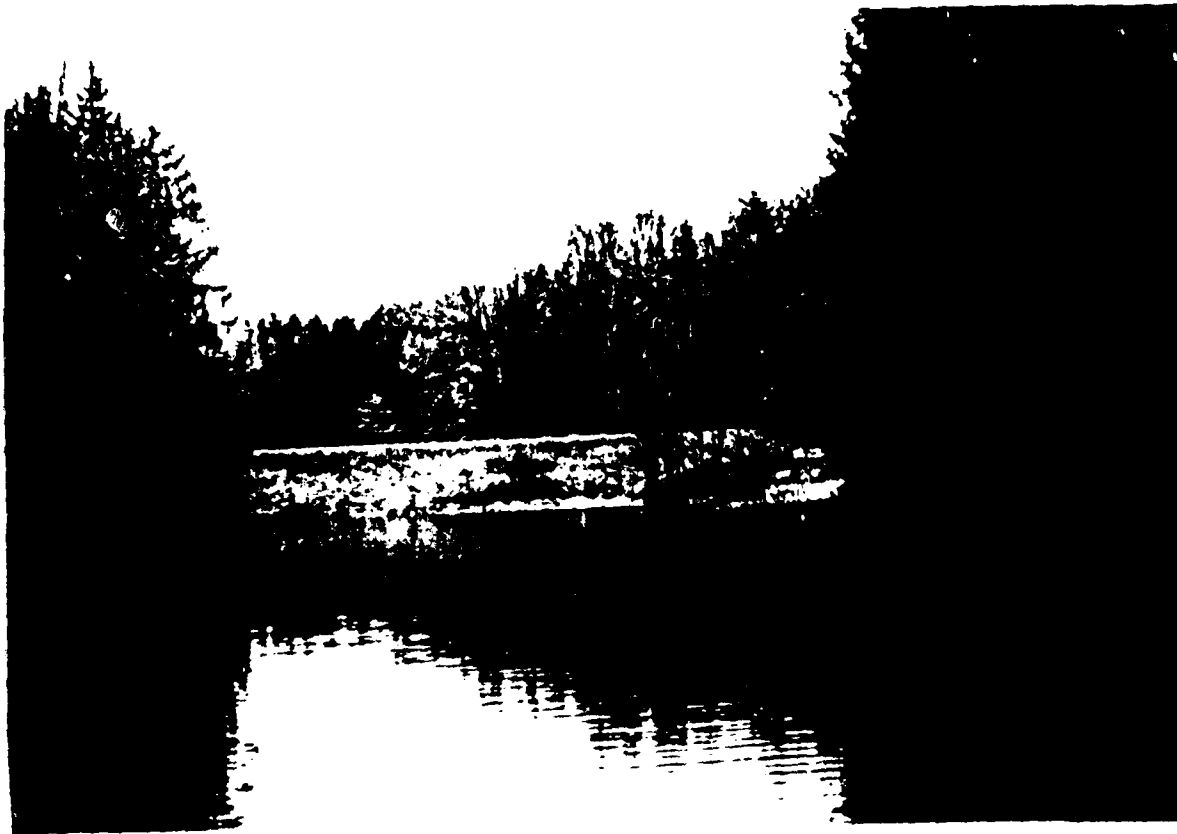
OVERVIEW OF DAM
